# SEWER COLLECTION SYSTEM ANNUAL REPORT

2017/2018

City of Lancaster

A report of the history, current assessment, budget, activities, and the achievements of the Lancaster, California Sewer Collection System in Fiscal Year 2017/2018.

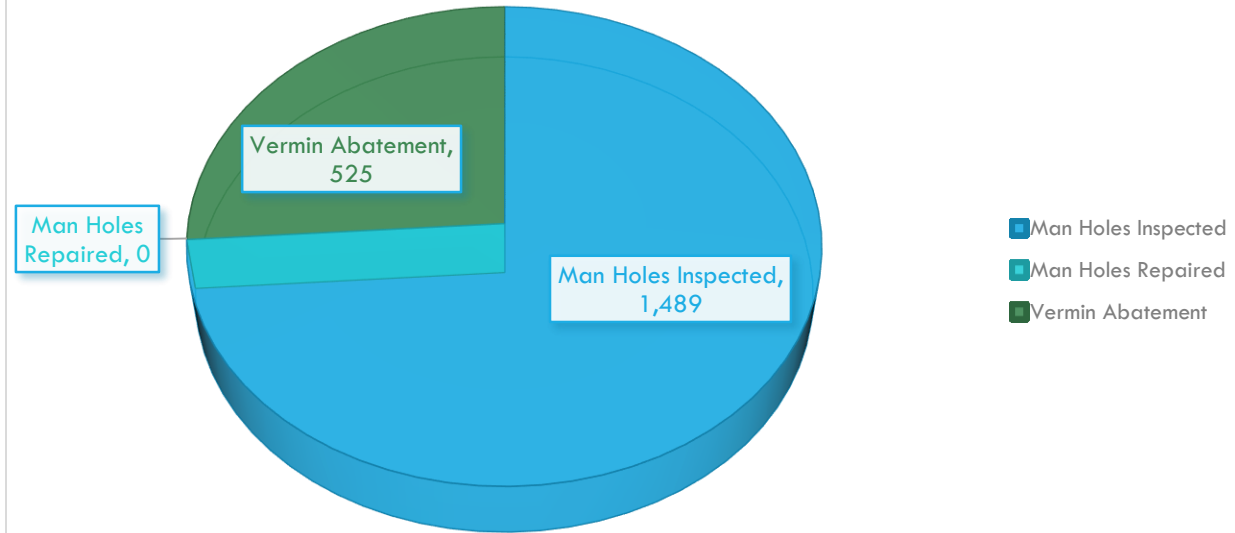
### MAN HOLE ACTIVITY

## 2017/2018 Annual Sewer Maintenance Activity at a Glance
